DEPARTMENT OF TRANSPORTATION**DIVISION OF ENGINEERING SERVICES**

Quality Assurance and Source Inspection

Contract #: 04-0120F4Cty: SF/ALA Rte: 80 PM: 13.2/13.9File #: 1.28**WELDING INSPECTION REPORT****Resident Engineer:** Pursell, Gary**Address:** 333 Burma Road**City:** Oakland, CA 94607**Report No:** WIR-015867**Date Inspected:** 27-Jul-2010**Project Name:** SAS Superstructure**OSM Arrival Time:** 1000**Prime Contractor:** American Bridge/Fluor Enterprises, a JV**OSM Departure Time:** 1830**Contractor:** American Bridge/Fluor Enterprises, a JV**Location:** Job Site**CWI Name:** John Pagliero**CWI Present:** Yes No**Inspected CWI report:** Yes No N/A**Rod Oven in Use:** Yes No N/A**Electrode to specification:** Yes No N/A**Weld Procedures Followed:** Yes No N/A**Qualified Welders:** Yes No N/A**Verified Joint Fit-up:** Yes No N/A**Approved Drawings:** Yes No N/A**Approved WPS:** Yes No N/A**Delayed / Cancelled:** Yes No N/A**Bridge No:** 34-0006**Component:** Orthotropic Box Girder**Summary of Items Observed:**

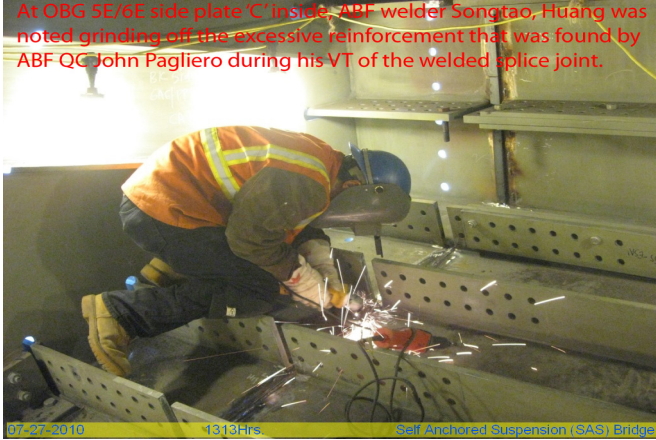
At OBG 5E/6E side plate 'C' (0mm to 1000mm) inside, it was previously reported that there were excessive weld cover reinforcement that were discovered by ABF QC. Today, QA noted welder Songtao, Huang grinding the excessive reinforcement to make it in compliance to the contract requirements. At the end of the shift, grinding of the excessive cover reinforcement was completed and excessive reinforcement was removed.

At OBG SE/6E side plate 'C' inside, ABF welder Songtao, Huang was noted grinding off the excessive reinforcement that was found by ABF QC John Pagliero during his VT of the welded splice joint.
